## Bisphenol-A Leaching from Water Bottles

prepared for

**SIGG USA**  
Stamford, CT

8 June 2007

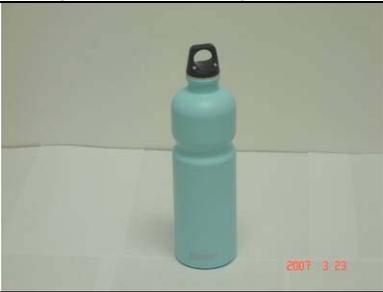
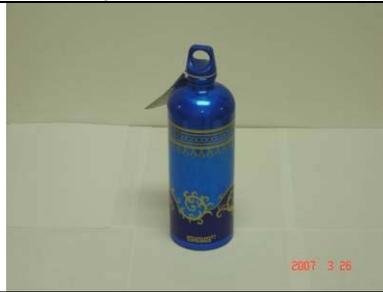
<p>New SIGG 20070075-01</p>

Figure 1: Typical Bottle Types and Sample Designations

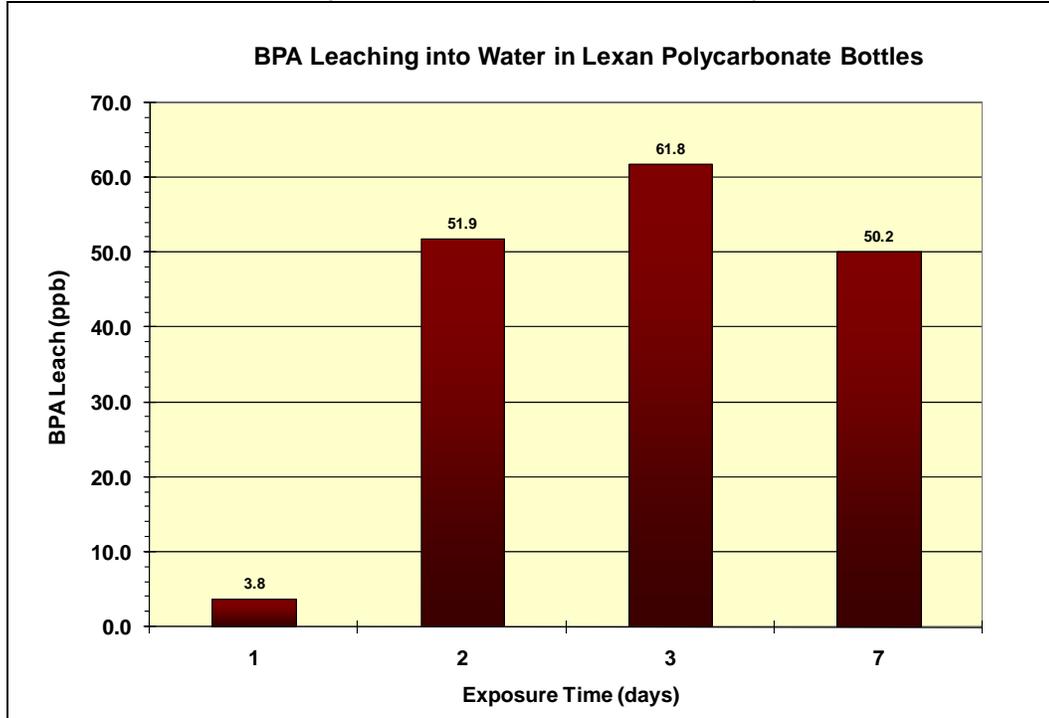
Figure 2. Lexan Exposure Time Study

Each Lexan bottle was filled with about 750mL of RO water and maintained at 90°C for 1, 2, 3, and 7 days. The liquid was then extracted for BPA and analyzed. Figure 2 summarizes the BPA leached as a function of time. Results were reported as parts per billion (ppb) and also normalized by the area exposed to the water (nanograms BPA leached per square centimeter of exposed surface area or  $\text{ng}/\text{cm}^2$ ). At 90°C, a significant increase in BPA leaching was observed in two and three days compared to one. As a result, 3 days was chosen as a time period that would produce a measurable BPA concentration.

In order to determine suitable exposure conditions 4 Lexan (polycarbonate #7) bottles were incubated with RO water over several days. At set time periods the bottles were removed from the oven and transferred to glass jars. The RO water from these bottles was extracted to determine the level of leachable BPA as a function of exposure time.

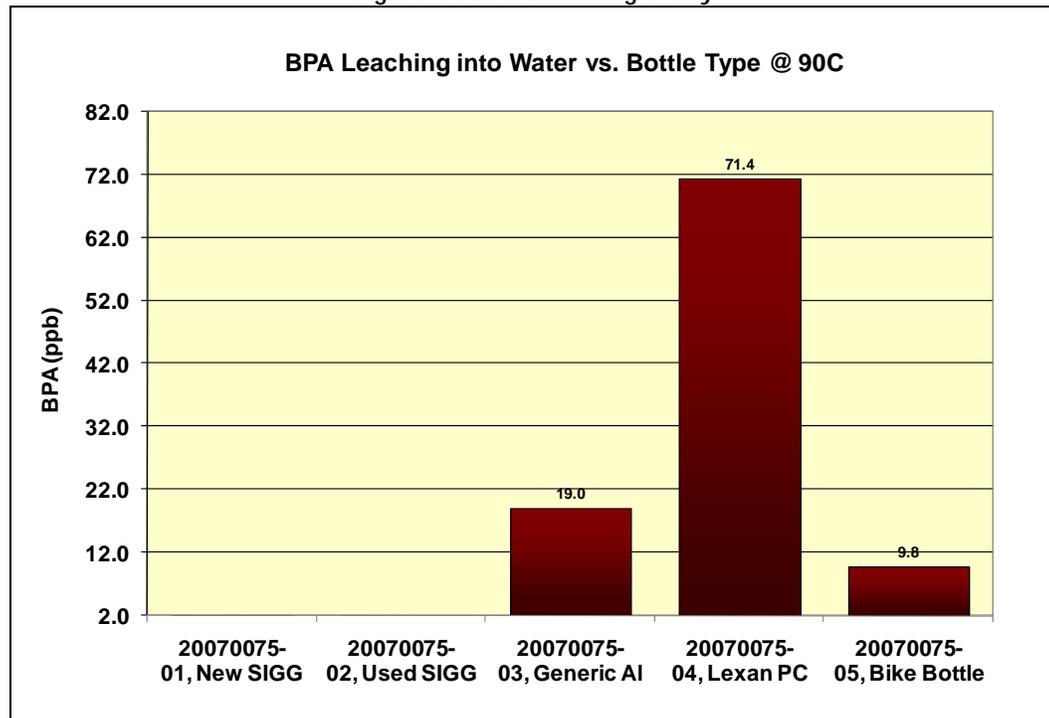
Figure 3. BPA Leaching Study

Bottles of each type (SIGG, Used SIGG, Lexan, generic Al, and Bike Bottle) were filled with 750-1000mL RO water and heated at 90°C for 3 days. The leachate was extracted for BPA and analyzed. Results are shown in Figure 3.

After 3 days, a significant amount of BPA,  $>70\text{ppb}$  ( $110\text{ng}/\text{cm}^2$ ), was leached from the Lexan water bottles compared to the other bottles. The generic Aluminum bottles showed the next highest levels of BPA with  $19\text{ppb}$  ( $32\text{ng}/\text{cm}^2$ ) detected followed by the polyethylene bottles with nearly  $10\text{ppb}$  ( $16\text{ng}/\text{cm}^2$ ).

In comparison, SIGG bottles fared extremely well. Based on this analytical method, the limit of quantitation (LOQ) for BPA was approximately  $2\text{ppb}$ . The LOQ is the level of BPA that can be determined reliably in these samples. Even under these extreme temperature conditions, no BPA was detectable in the SIGG bottles above this LOQ.
